**Settle Load test May 15, 2009 - TEI/IMS Mfg Plant Report**

A settle load test was performed on a Pro Pac Pro Cot model number L2030-SRG Oversized Special Needs Cot. The cot was constructed out of painted aluminum with a woven mesh decking material. The decking material was secured to the frame by a plastic rope spline inserted into the sewn pockets of the decking and then inserted into a channel in the extruded aluminum frame rail. The cot measured 30.5 x 79.5 x 19.75 tall.

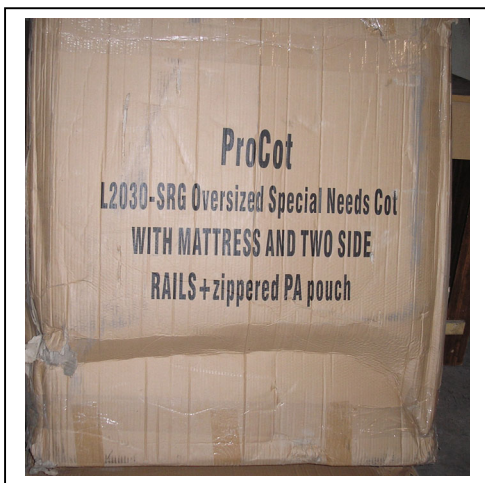
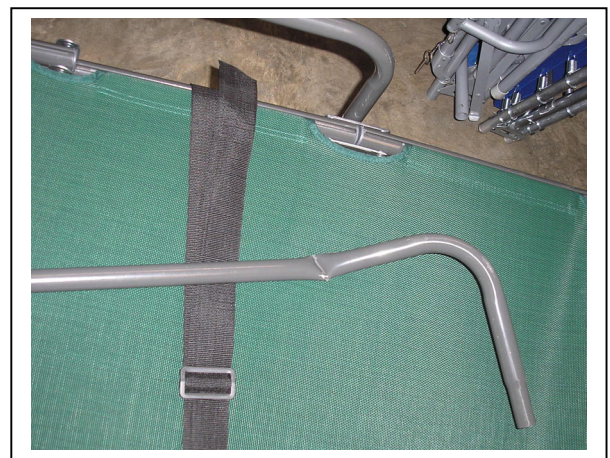
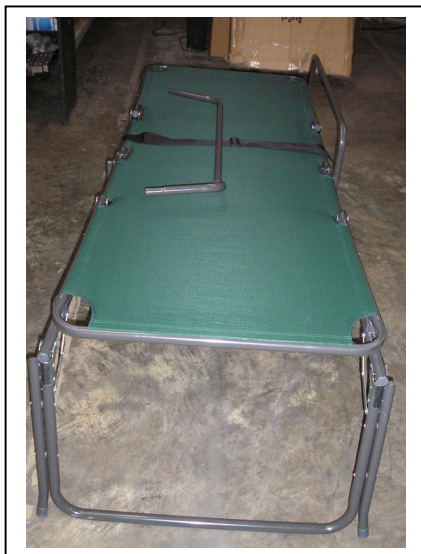
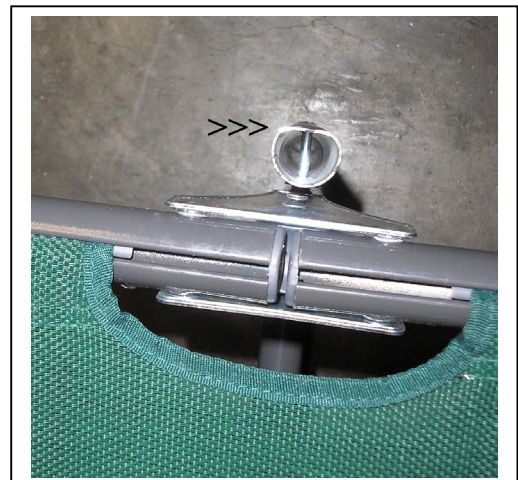
The cot experienced catastrophic failure on the 21<sup>st</sup> application of 450 lbs. The main frame broke at the hole pierced in the frame to accept the rivet that secures the U clip to the frame and the inclinable back. The speed of the collapse was astounding. It pitched the cot violently to the left ripping the leg from the floor mounted bracket that was keeping the cot in place

1. The cross braces that connect the two sides of the cot are made of painted steel and not mechanically connected to the frame. They are merely spacers held in place by way of loose fitting plastic plugs. See pix
2. The above mentioned braces/spacers are used to support the foot and head incline adjusters.
3. The cot main frame is basically held together by ONLY the center leg T bracket which is riveted.

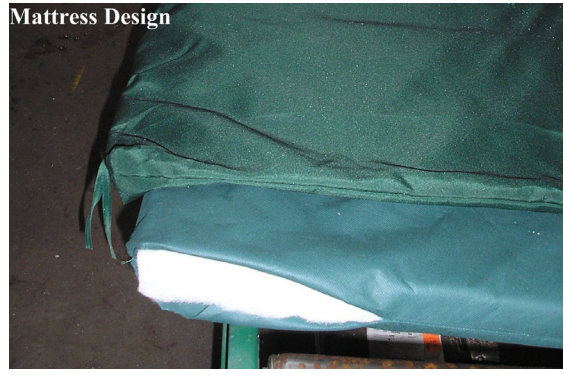
Mattress Design

A mattress was included in the carton. It was constructed utilizing a woven polyester hollow-fill type product stuffing sealed into a light weight bag and then covered by a removable zippered cover.
